Statement of Dr Per von Scheibner

I, Dr Per von Scheibner, of [address redacted], wish to make the following Statement in opposition to Planning Applications Nos 09/2598/F and 09/2599/L submitted to Greenwich Council by LOCOG for the use of Greenwich Park for the 2012 Equestrian Olympics. I am happy for NOGOE to include this statement in support of their own opposition.

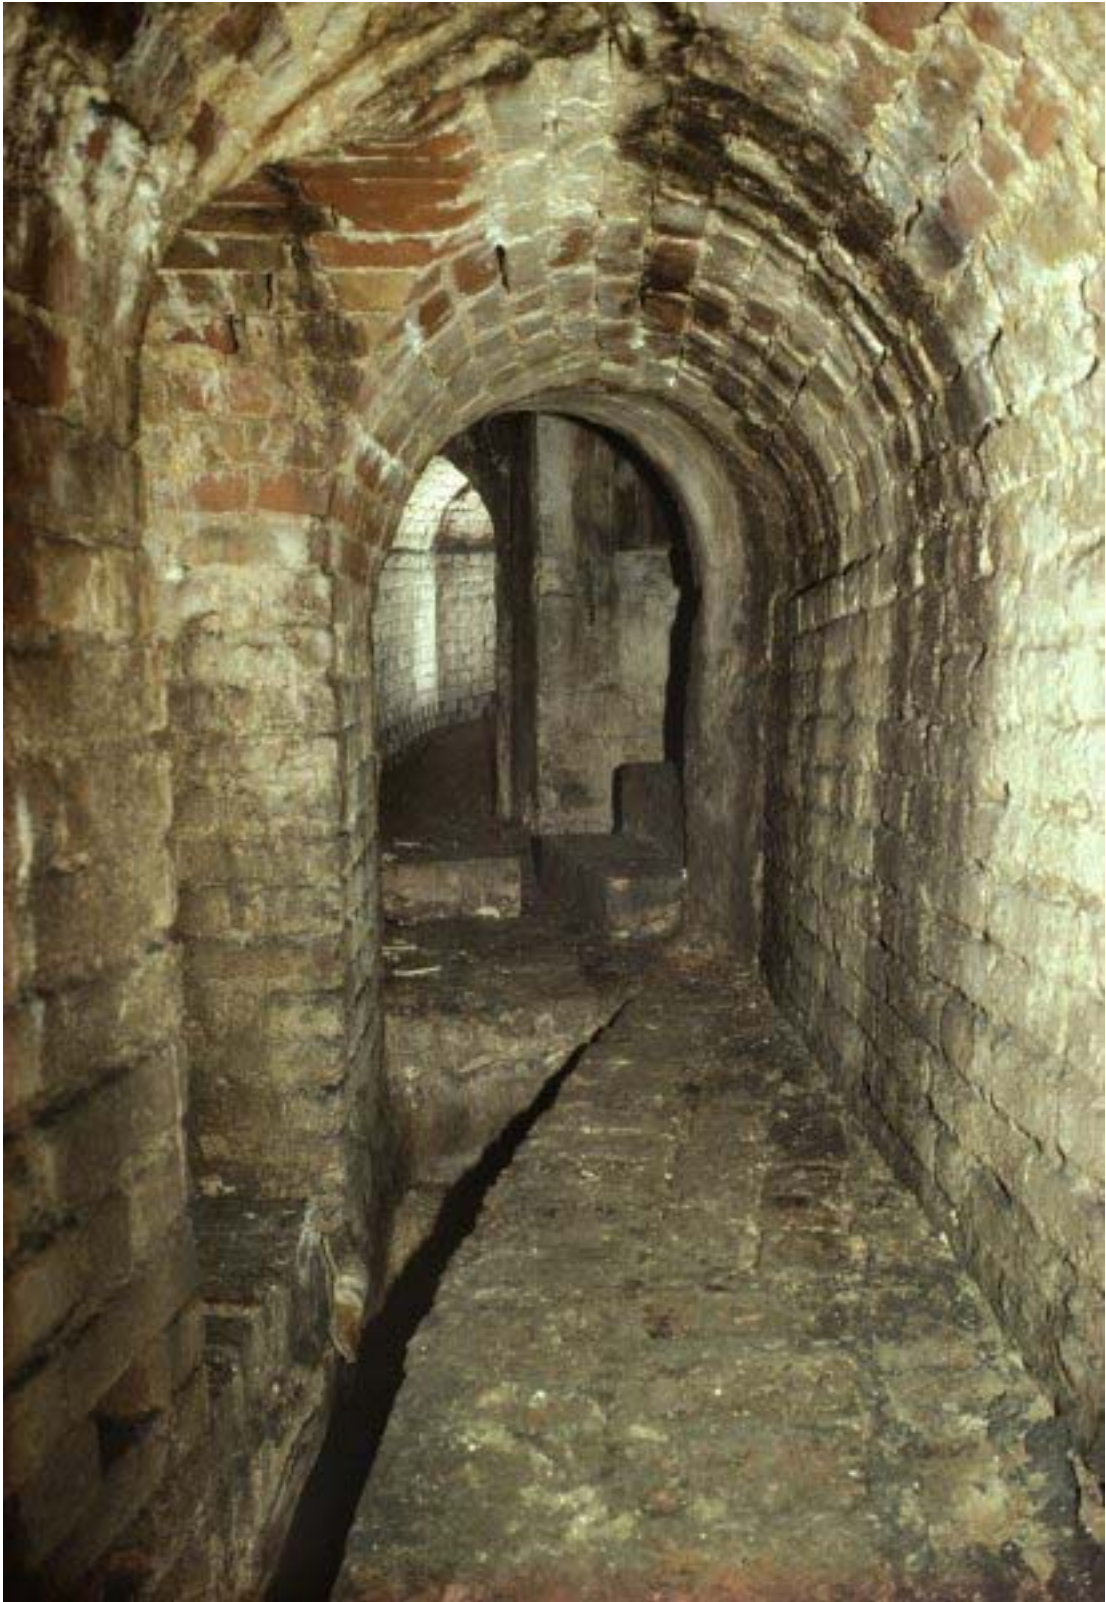
9. The conduits, both older and more recent, were designed to collect subterranean water of all kinds, including that from springs. The design of the more recent conduits is illustrated in the photograph below (*see next page*).

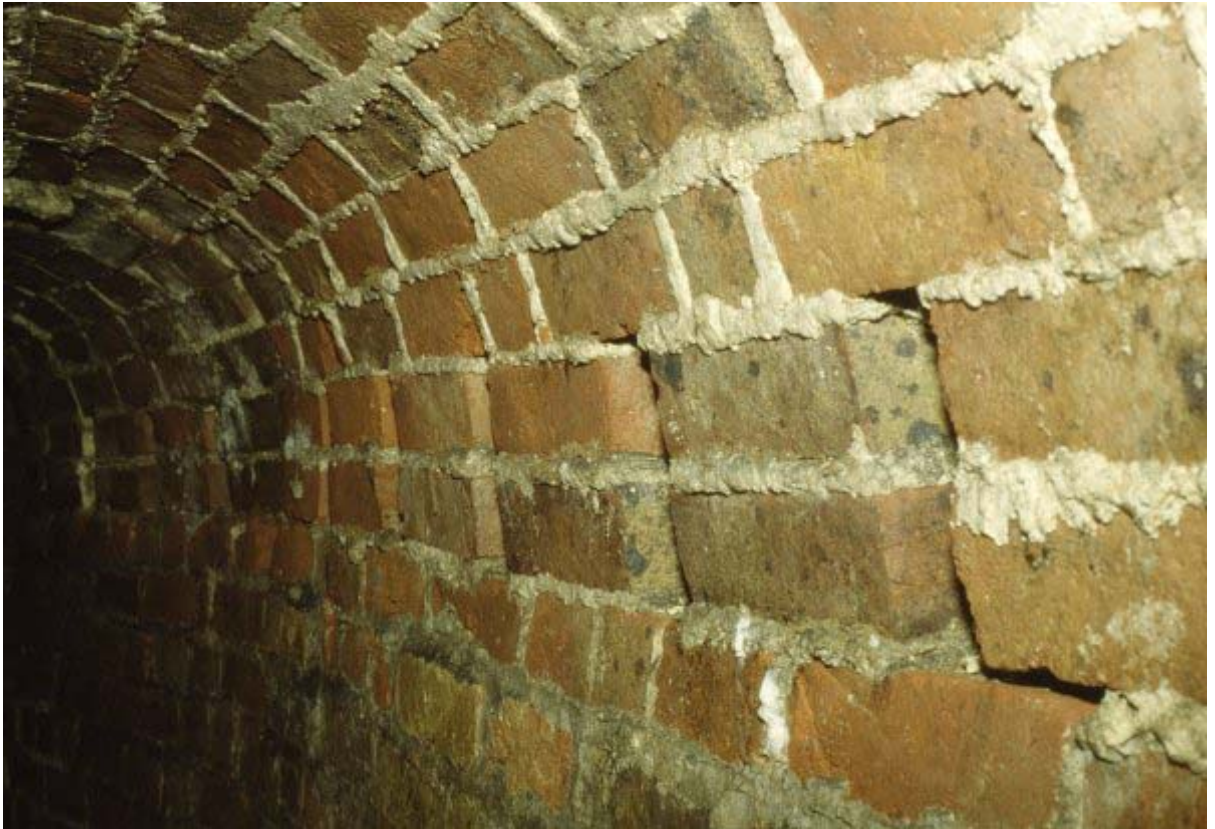
They are built of brick, and are generally about 4 to 6 feet high and about 2 feet to 4 feet wide and generally run between mere inches to some thirty feet or more below ground level. At the top is a rounded or Gothic arch. At the bottom of the conduit walls are gaps in the brickwork to allow water to feed into the conduit (see photograph below).

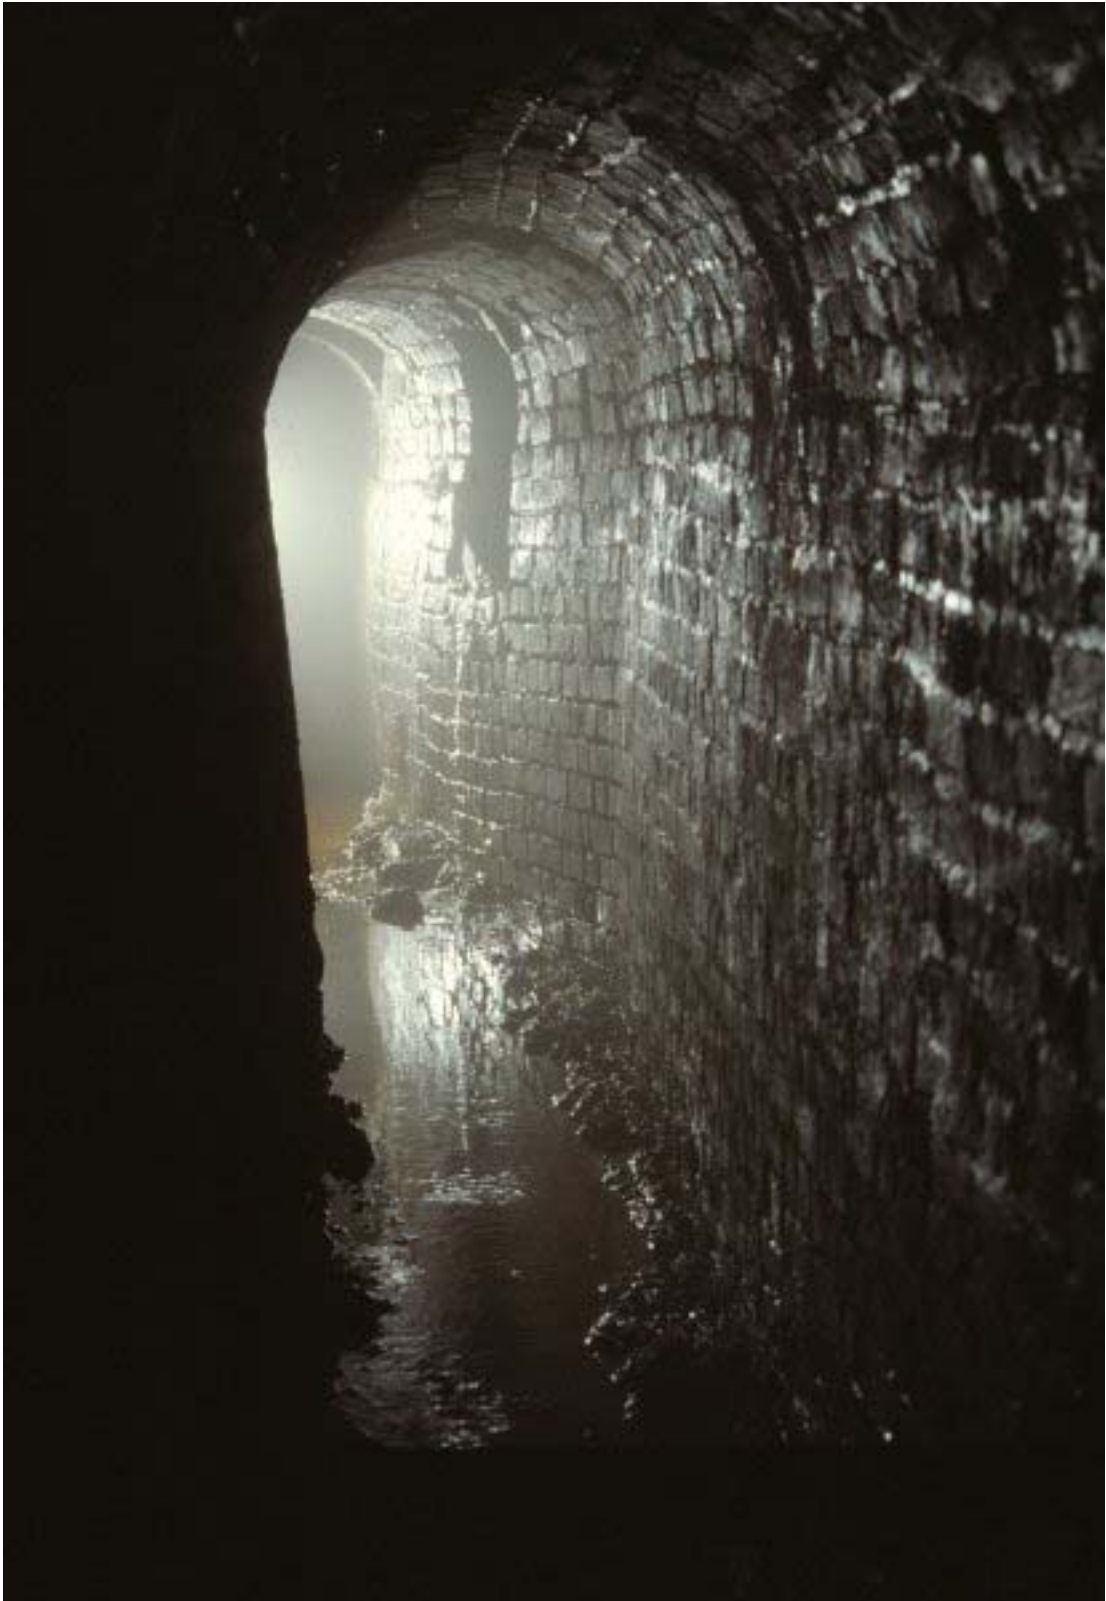
11. Both types of conduit worked satisfactorily so long as they were properly inspected and maintained. Once this ceased, there started to be a build-up of sand inside the tunnels washed in from the outside of the intercept brick walls. This can be seen in the photograph below. As the sand was washed in from alongside the outer wall of

the conduit, voids were created on the outside. This in turn would allow water to put pressure on the affected conduit walls which would start to bulge (see photograph below).

Exactly how and where a future collapse is going to happen is illustrated by the picture taken inside the Croom's Hill Conduit (the section omitted in recent surveys by English Heritage and others) during my survey and the one undertaken by the late Richard Moy. The photograph under paragraph 11 clearly shows the collapsed tunnel wall and the void that got created behind it. The question is not if there will be a surface collapse but only how long it will take for the void to reach the surface.

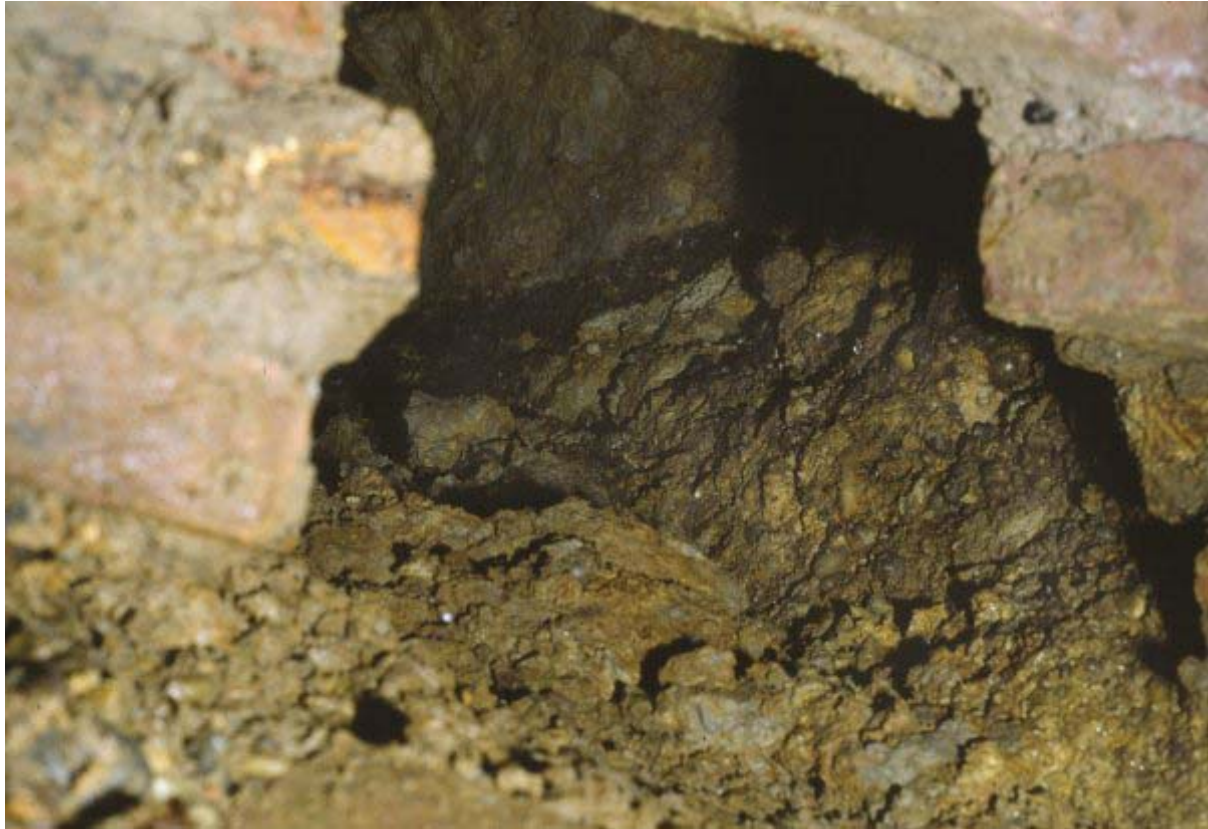
This could – and in several cases did – lead to a collapse of the conduit wall, through which large quantities of water and soil would enter, thereby creating gradually an ever larger void on the outside of the original conduit (see photograph below which shows such a breach in the wall – the actual dimension of the hole is about three feet across).

On the surface this void will be protected for a given time by roots, grass, the actual soil adhesion, etc – but it will be liable to collapse at some point for a variety of reasons, ie exposure to large amounts of water, drought – or simply weight or pressure from above.

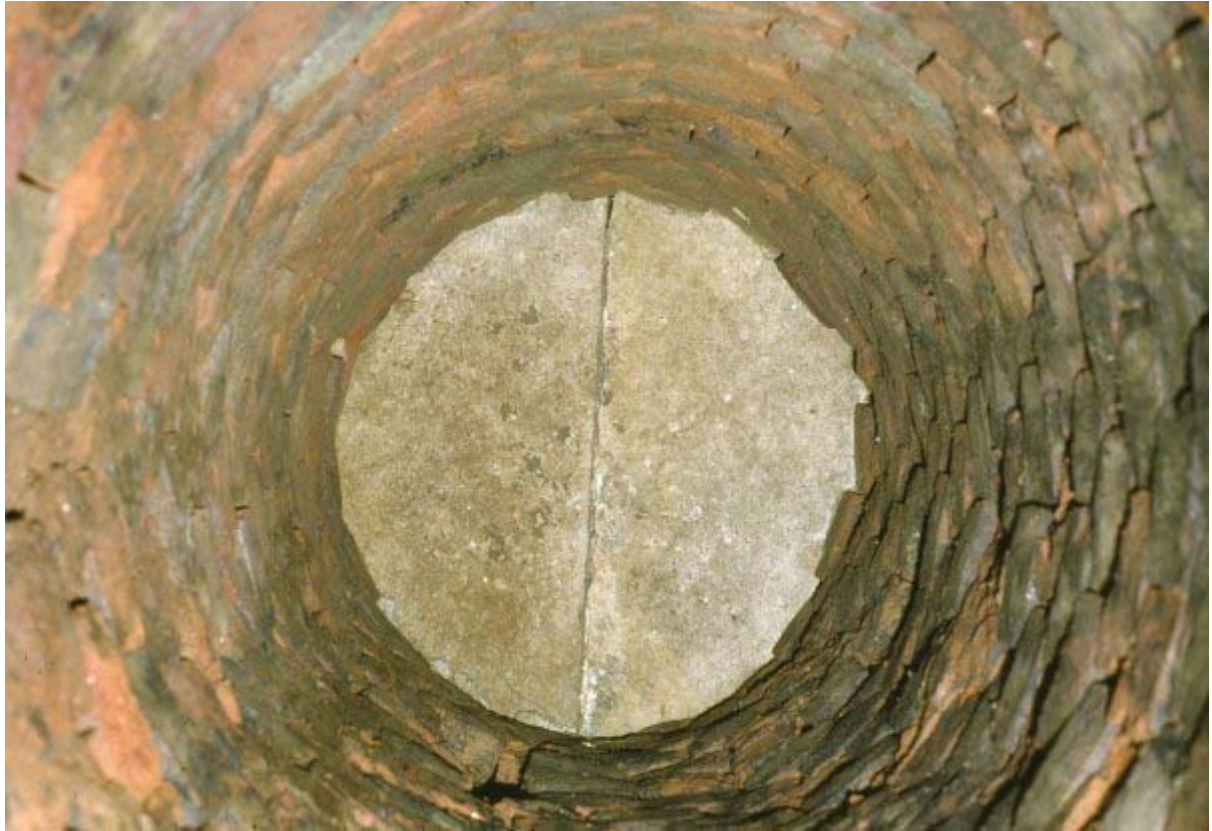
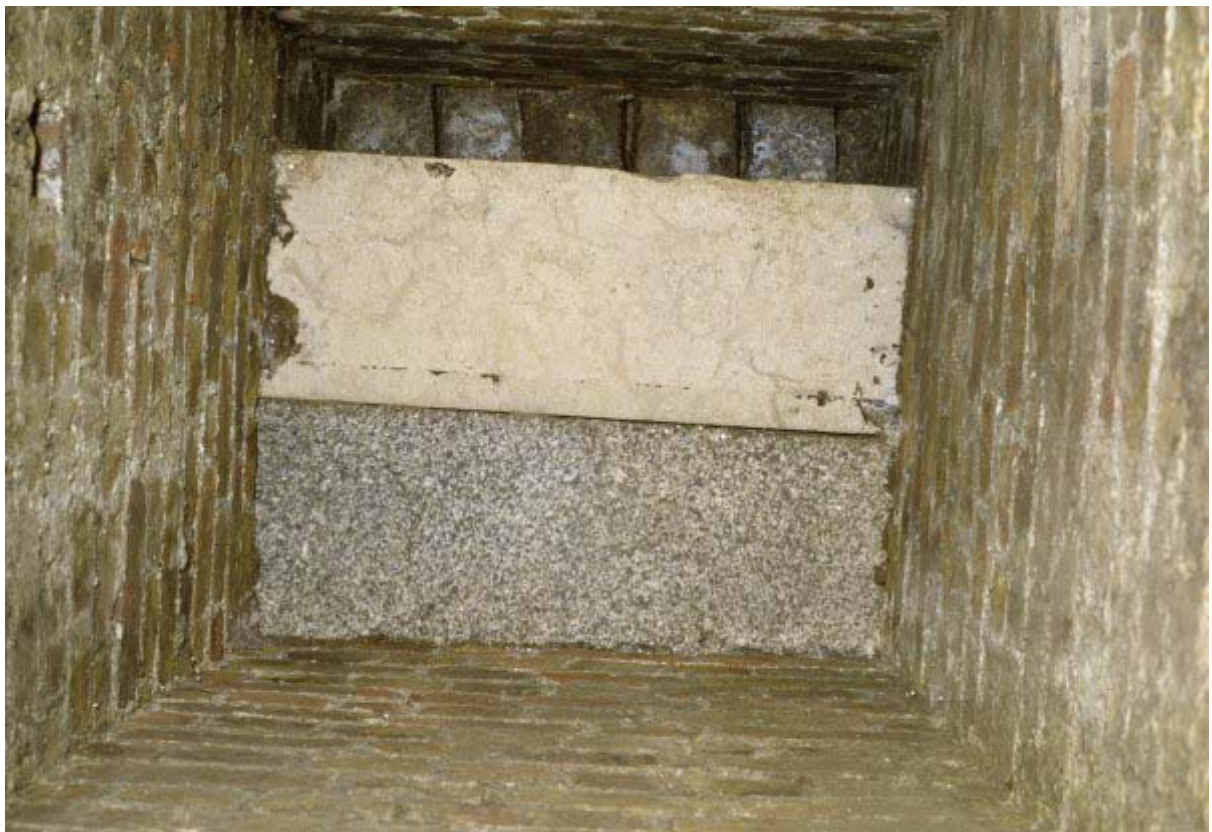
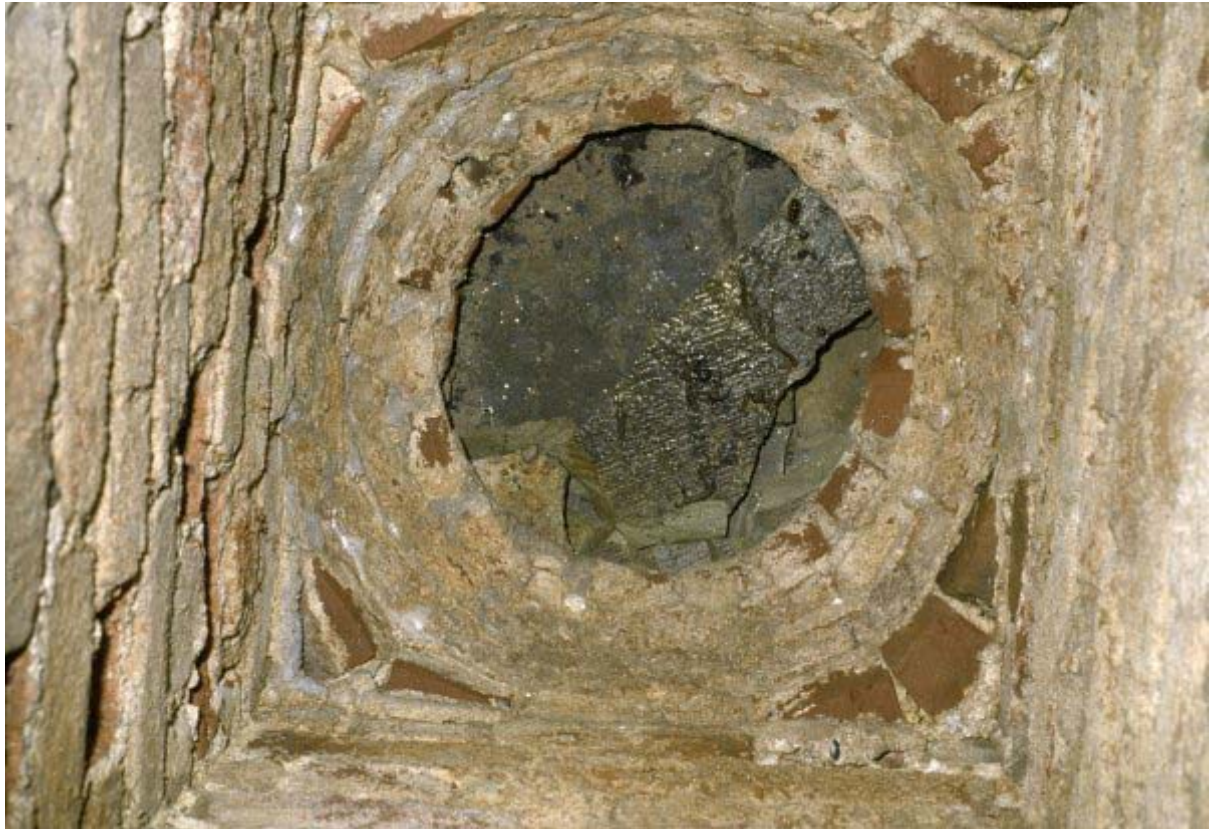
12. The other major danger is the way in which the inspection shafts on both types of conduit are capped at ground level. The original methodology was no doubt satisfactory when the conduits were being maintained. However, as time went by the original covers tended to be replaced by less satisfactory alternatives. This is illustrated in the three photographs below, from which it can be seen that all too often shafts are now capped simply by two stones side by side, by roof slates, or by breeze blocks of uncertain strength. (I am also aware of one access shaft which is simply capped by a wooden board.) An additional problem is that many of the access shafts – known and unknown – are well hidden from view and so it is virtually impossible to ascertain if they pose any danger to the public.
